MECTROL

CASE STUDY

- END MARKET < > PORK PROCESSING
- APPLICATION < > TRIM CONVEYOR
- ORIGINAL PARTS < > PLASTIC MODULAR BELT
- SOLUTION < > GATES MECTROL POSICLEAN® PC20

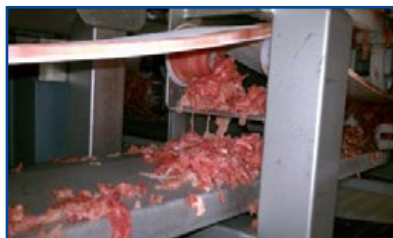
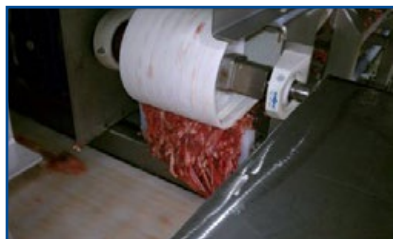
BEFORE

- > A national meat processor was experiencing high scrap losses because the meat was getting trapped in the plastic modular belting openings.
- > Additional losses were incurred because the scraper could not be correctly positioned due to the chordal effect created as the plastic modular belt wrapped around the pulley.

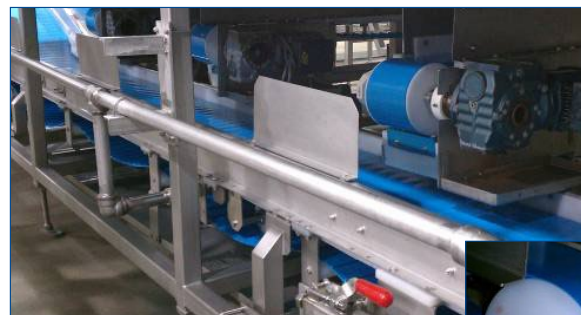
AFTER

- > The plastic modular belting was replaced with Gates Mectrol's PC20 PosiClean belt, a 2" pitch, smooth surface urethane belt with embedded tension members.
- > The smooth continuous belt surface prevented any loss of meat during conveyance and allowed for the belt scraper to be positioned at the top of the drive pulley.

- > Trim loss was reduced from 1,200 lbs. per day to less than 200 lbs.
- > Production was increased by \$135k per year.
- > The clean-in-place feature cut water consumption by 181,000 gallons annually.
- > Reduced water usage and waste water disposal saved the plant \$22,000.
- > The belts paid for themselves **in less than three weeks.**
