TECH TIP COOLING SYSTEM

BULLETIN TT006-16

Automotive Sealant Use During Water Pump Replacement

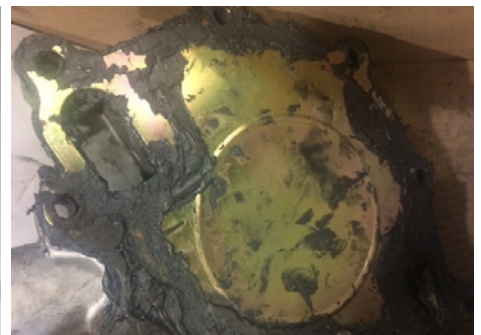
Both pumps were supplied with a cellulose / rubber binder gasket. These gaskets do not require the use of any sealants. However if the mating surface is damaged a small skim coat of sealant is allowable with these types of gaskets.

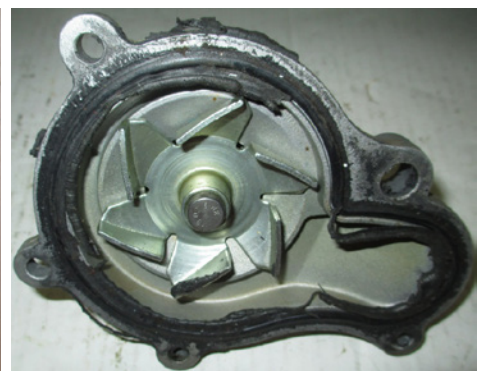
Both pumps were supplied with a rubber / O-ring style gasket. These types of gaskets do not require the use of any sealants.

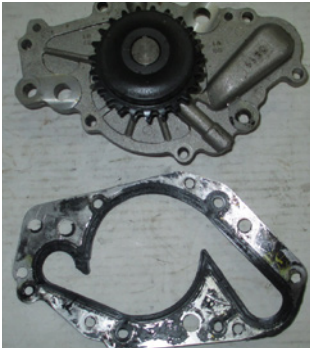
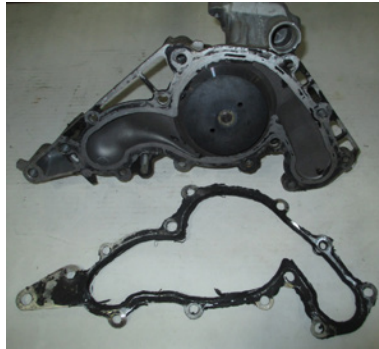
Both pumps to the left were supplied with a metal gasket with a rubber lining the interior perimeter. This type of gasket does not require any sealer. It is clear that over use and misuse of sealants occurred. Installation practices of this nature will lead to premature water pump failures. Premature failures lead to product reliability / quality concerns from customers when in actuality the failure arose from miss-installation / improper use of sealants.

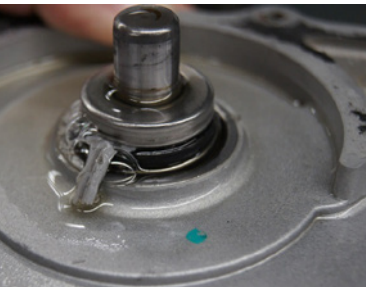
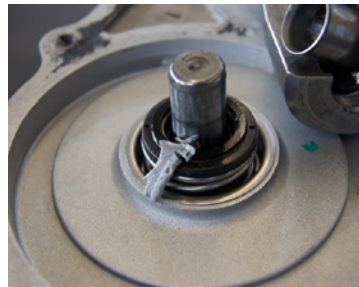
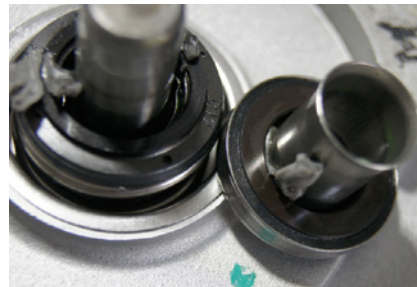
In the examples below one can see where sealer material has been found within the cartridge seal and has led to premature leakage of the water pump and the customer returned the pumps as an alleged manufacturer defect.

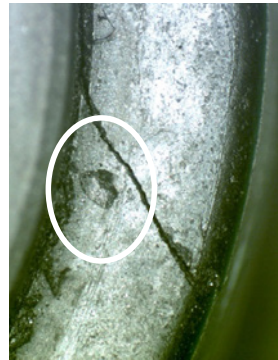
To the left are examples of Dynamic and Static seal contamination / filming caused by over use of sealants. When sealant particulates / residue get trapped between the Dynamic and Static seal faces it causes a separation of the two surfaces which leads to a seal leak.
